# **Making the Best of a Bad Situation: From leaking UST Over Fractured Bedrock with Closed Municipal Wells to Case Closure – A Success Story**

Warren Gross, P.G., C.E.G., C.H.G.

CRWQCB – Region 5, Fresno

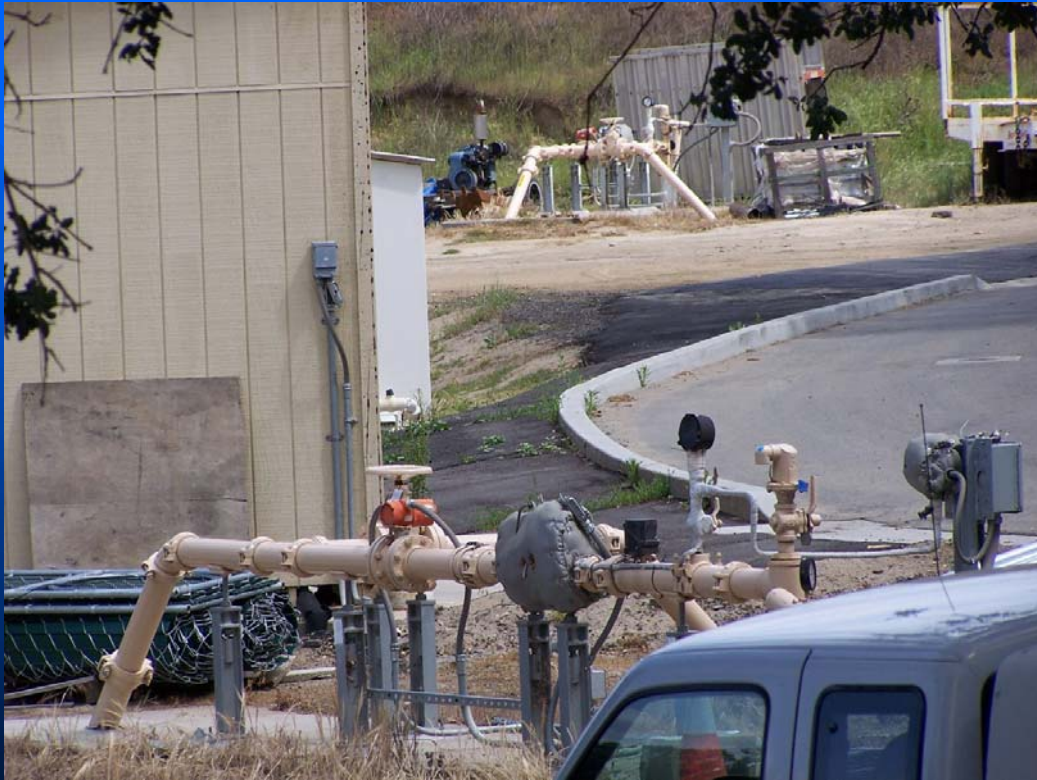
# Impacted Supply Wells

The additive known as MTBE was found last month in the well at Yosemite Lakes Park, about seven miles south of Coarsegold.

Yosemite Springs Park Utility — the water company that provides water to the park — shut down the well as soon as the contamination was found, said Ken Harrington, the company's manager.

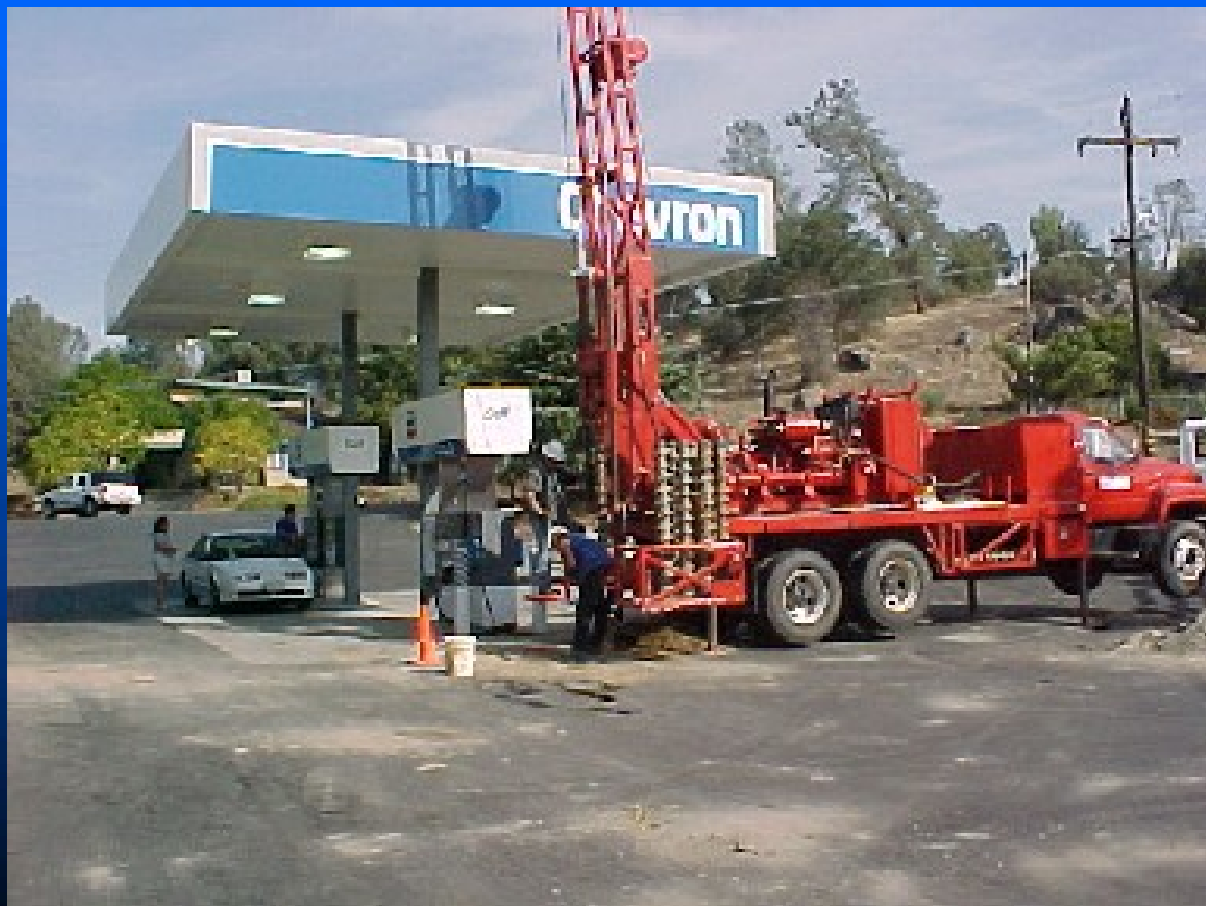
# Soil Assessment

TPHg 160 mg/kg  
Benzene 0.5 mg/kg  
MTBE 120 mg/kg

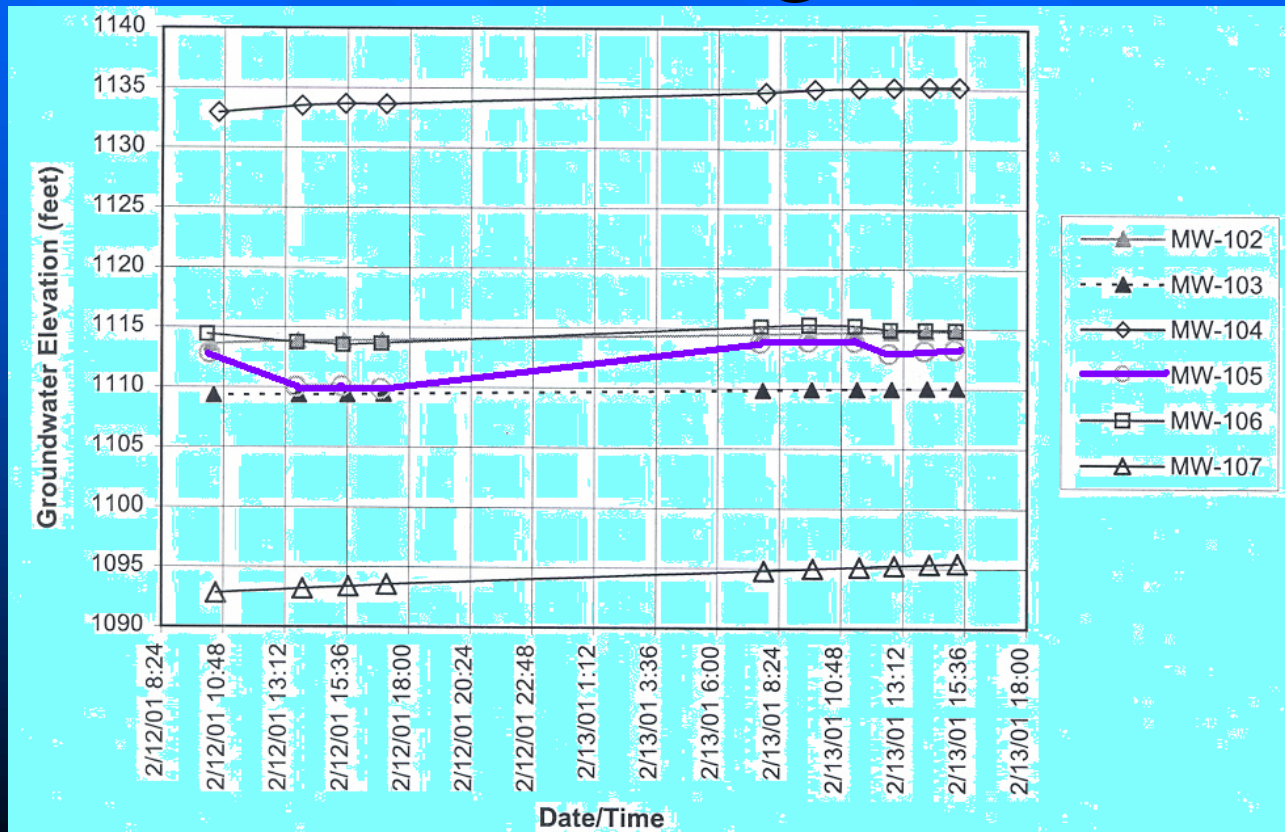
# GW response to Packer Testing

Fracture Depth Ft / Yield (gpm)	MTBE(ug/L)	TBA (ug/L)
77 / 1.5	2,500	<2,000
87 / 0.8	2,800	<4,000
103 / 3.3	3,300	<4,000
152 / 0.08	1,600	<1,000
162 / 3.5	430	<1,000
208 / 2.25	260	4.2
220 / 4.0	820	<1,000

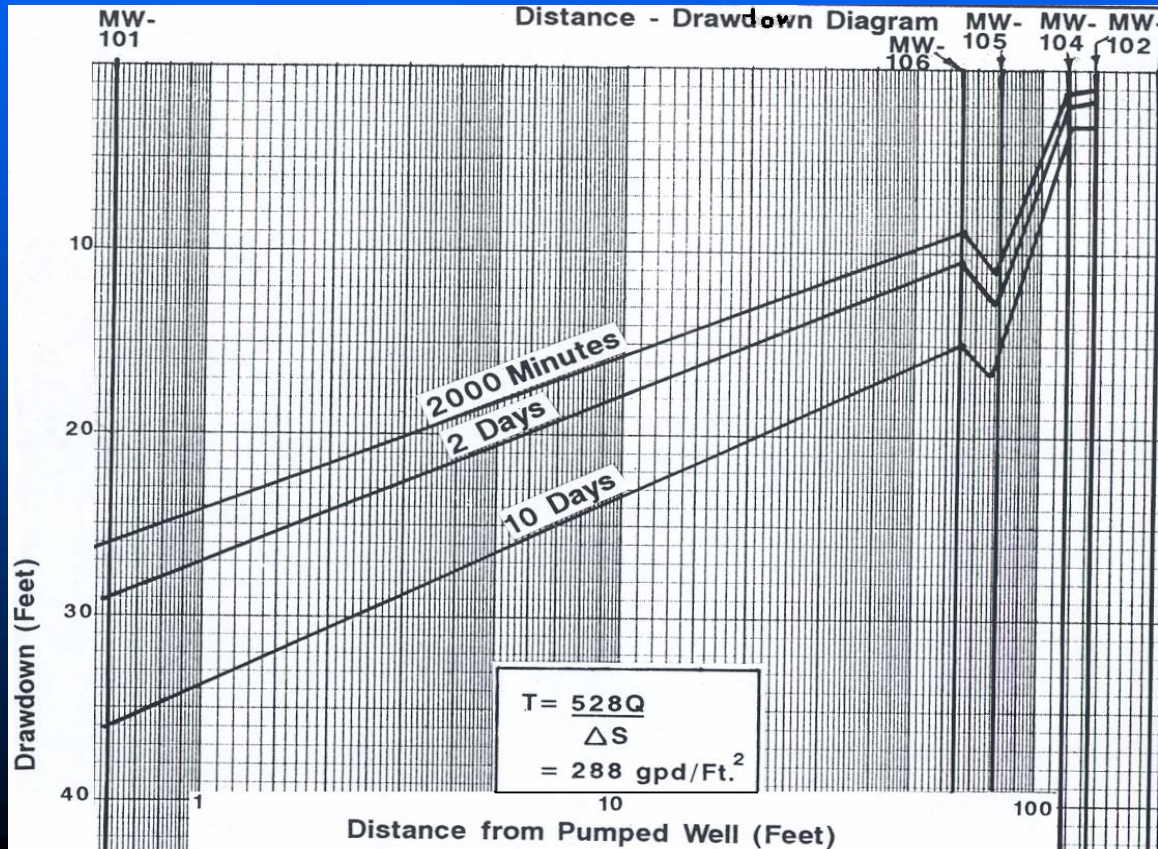
# Distance-Drawdown Relationships

- 48-hour
- MTBE/TBA 1,200/2,600 ug/L after 24 hrs
- MTBE/TBA 997/2,200 ug/L after 48 hrs

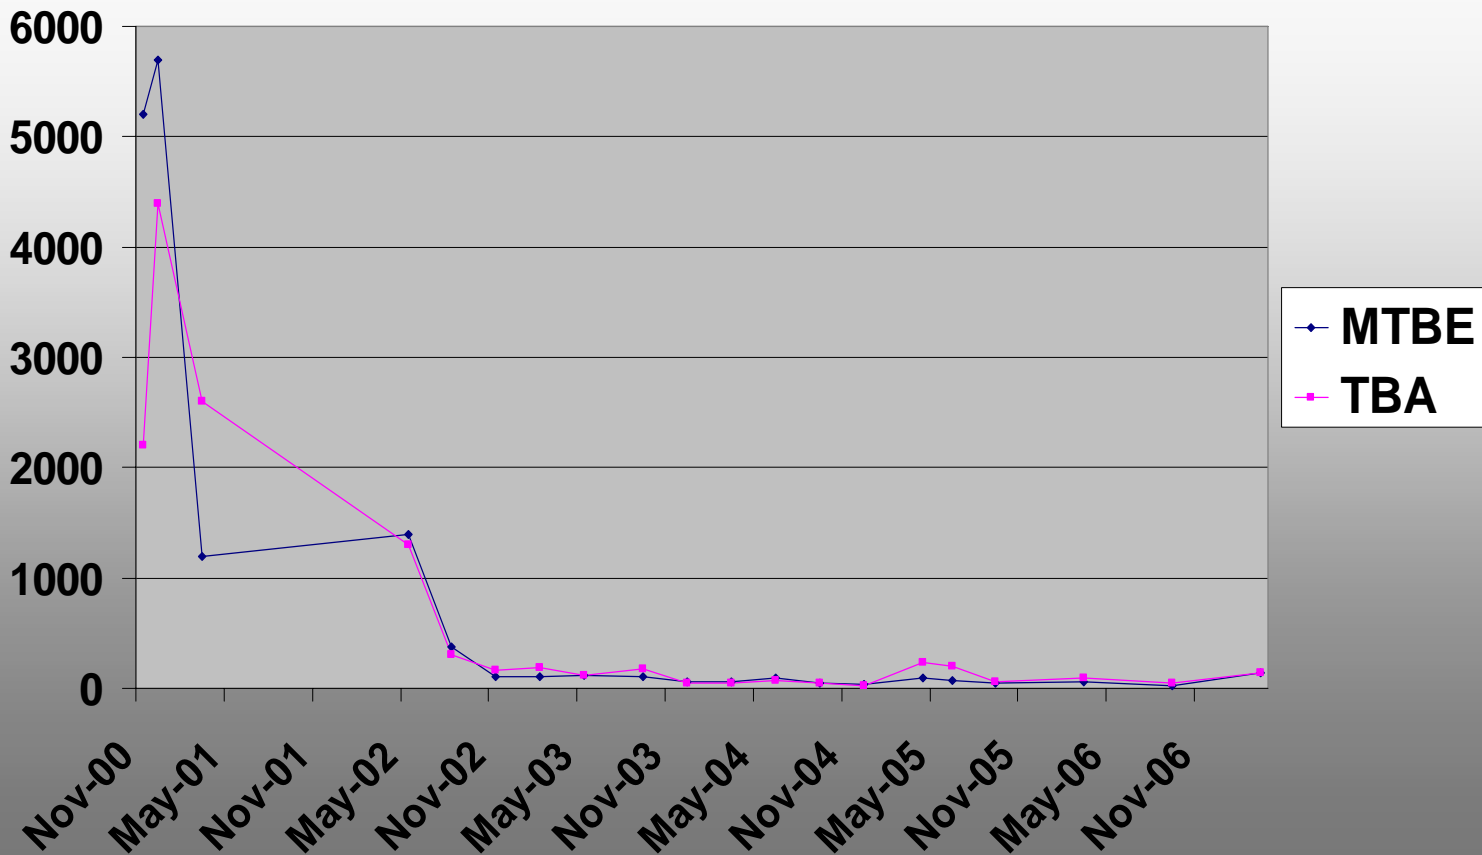
# MW-101

- MTBE is relatively persistent within the aquifer, degrading slowly to TBA as oxygen is available and likely assisted by leachfield bacteria.
- MW-101 is well connected hydraulically to the MTBE plume from the station, as well as to the fault water supply feeding the impacted water supply wells.
- Groundwater extraction from MW-101 on a continuous basis at a rate of approximately 10 gpm appears feasible and is recommended.
- On site treatment for the produced water should be provided prior to discharge.
